Philip Transportation and Remediation, Inc.

RE: REPORT OF ACTIVITIES
FOR THE WEEK ENDING MARCH 30, 2003
YERINGTON MINE
ELECTROWINNING FLUIDS AND DRUM REMOVAL

RE: REPORT OF ACTIVITIES
FOR THE WEEK ENDING APRIL 6, 2003
YERINGTON MINE
ELECTROWINNING FLUIDS AND DRUM REMOVAL

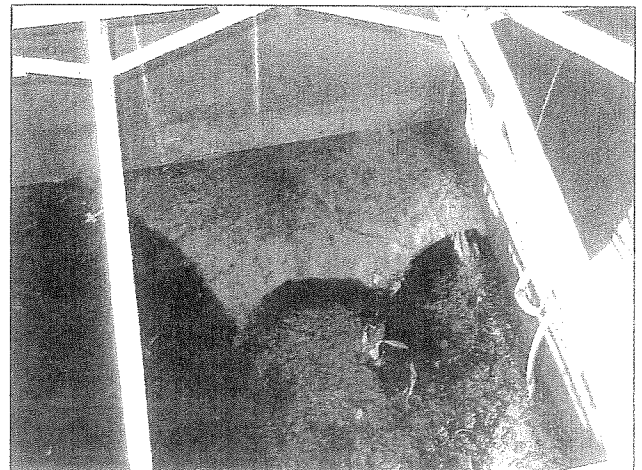
Consolidation of fluids to tank D

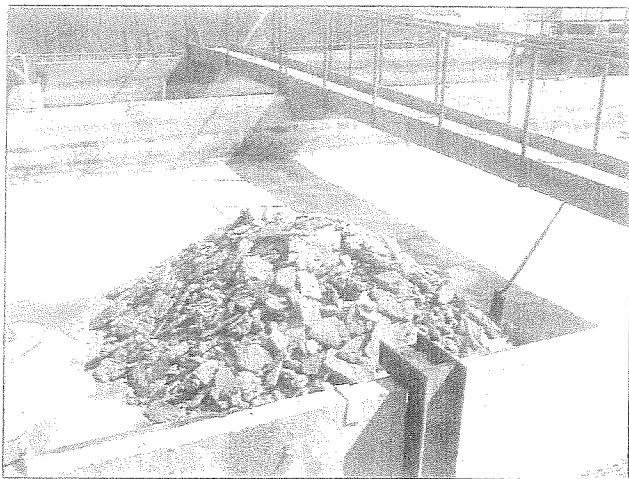
Copper Sulfate in large portion of S-1.

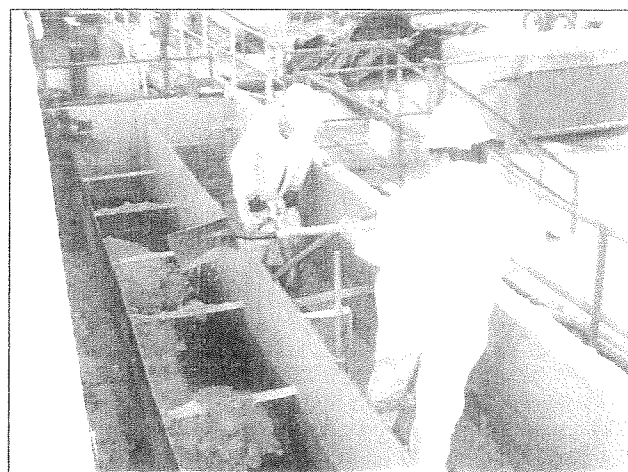
Jack hammering copper sulfate from S-1 weir.

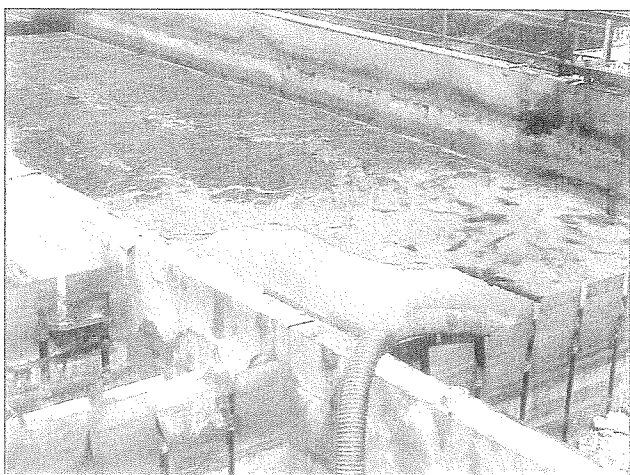
Organic crud in small portion of S-1.
